# MAST ARM AND STRAIN POLE INSPECTIONS

## METAL TRAFFIC SIGNAL POLE INSPECTION REPORT

MUNICIPALITY: PITTSBORO STRUCTURE TYPE ID: SMA-CA10  
COUNTY: CHATHAM POLE STRUCTURE NO. 105000 SIGNAL ID NO. 08-0001  
ROUTE: US 15-501 POLE QUADRANT: NORTHEAST  
LOCATION: JCT. US 15-501 W/ SALISBURY ST.  
DESCRIPTION: 1 ARM, ARCHED GALVANIZED STEEL MAST ARM W/ (4) 1-1/4"ø A.B. BASE  
PRESENT CONDITION: FAIR COMPUTER UPDATE: \_\_\_\_\_  
INSPECTION DATE: 3/05/2003 INSPECTION CYCLE: 4 YEAR  
INSPECTED BY: WILLIAM L. YINGER, PE GPS READING: 35D 43.304M N  
REVIEWED BY: TL. BARTLEY 79D 10.617M W  
SPECIAL CONDITIONS: OH POWER APPROX. 8' ABOVE POLE

MUNICIPALITY: PITTSBORO STRUCTURE TYPE ID: SW-DS15  
COUNTY: CHATHAM POLE STRUCTURE NO. 185003 SIGNAL ID NO. 08-0247  
ROUTE: US 64 POLE QUADRANT: NORTHEAST  
LOCATION: JCT US 64 W/ NC 87-902

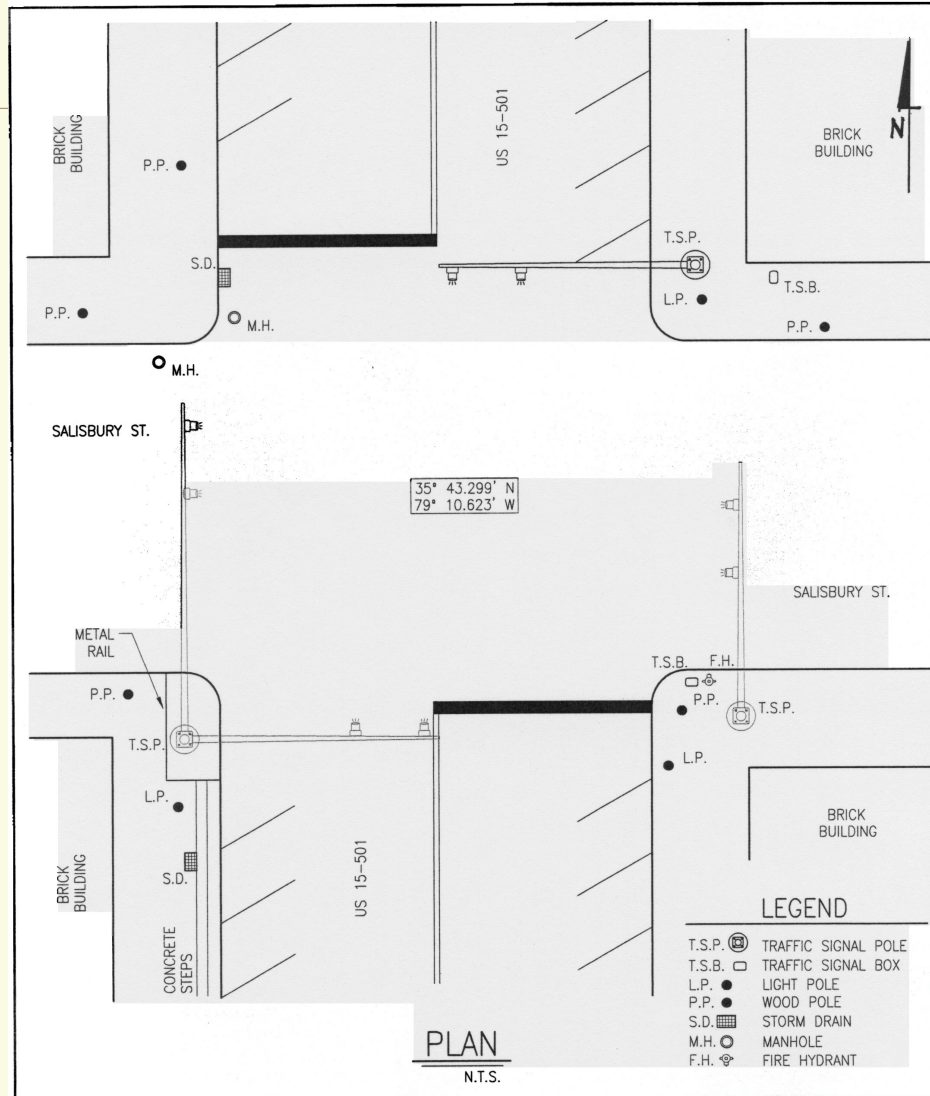
# FIELD SKETCH

ITEM	RATING	DESCRIPTION
1a FOOTING	- NO GRADE	There is a brick sidewalk around the base. Appears to be sand (no grout) under baseplate. Could not inspect foundation.
1c ANCHOR RODS	7 GOOD	Surface rust on projecting ends.
1e ANCHOR ROD NUTS	4 POOR	No flat washers at anchor bolt nuts (only lock washers).
3a MAST ARM CONN. PLATES	7 GOOD	Few spots of surface rust.
4a MAST ARM A	7 GOOD	1 spot surface rust at 2 ft. from end.
5 CONNECTION OF SIGNAL HEADS TO ARM	7 GOOD	Connection hardware rusted.
6 CONNECTION OF SIGNS TO ARM	7 GOOD	Connection hardware rusted.
INSPECTED BY:	WLY	REVIEWED BY: TJS

MAINTENANCE NEEDS			
INSPECTION TYPE: ROUTINE		INSP. DATE: 3/06/2003	
COUNTY: CHATHAM	POLE STRUCTURE NO.: 185000		POLE QUADRANT: NORTHEAST
ROUTE: US 15-501		SIGNAL ID NO.: 08-0001	
LOCATION: JCT. US 15-501 W/ SALISBURY ST.			
NO.	DESCRIPTION		
1	Provide flat washers under lock washers at all 4 anchor bolts.		
INSPECTED BY: WLY			
REVIEWED BY: TLB

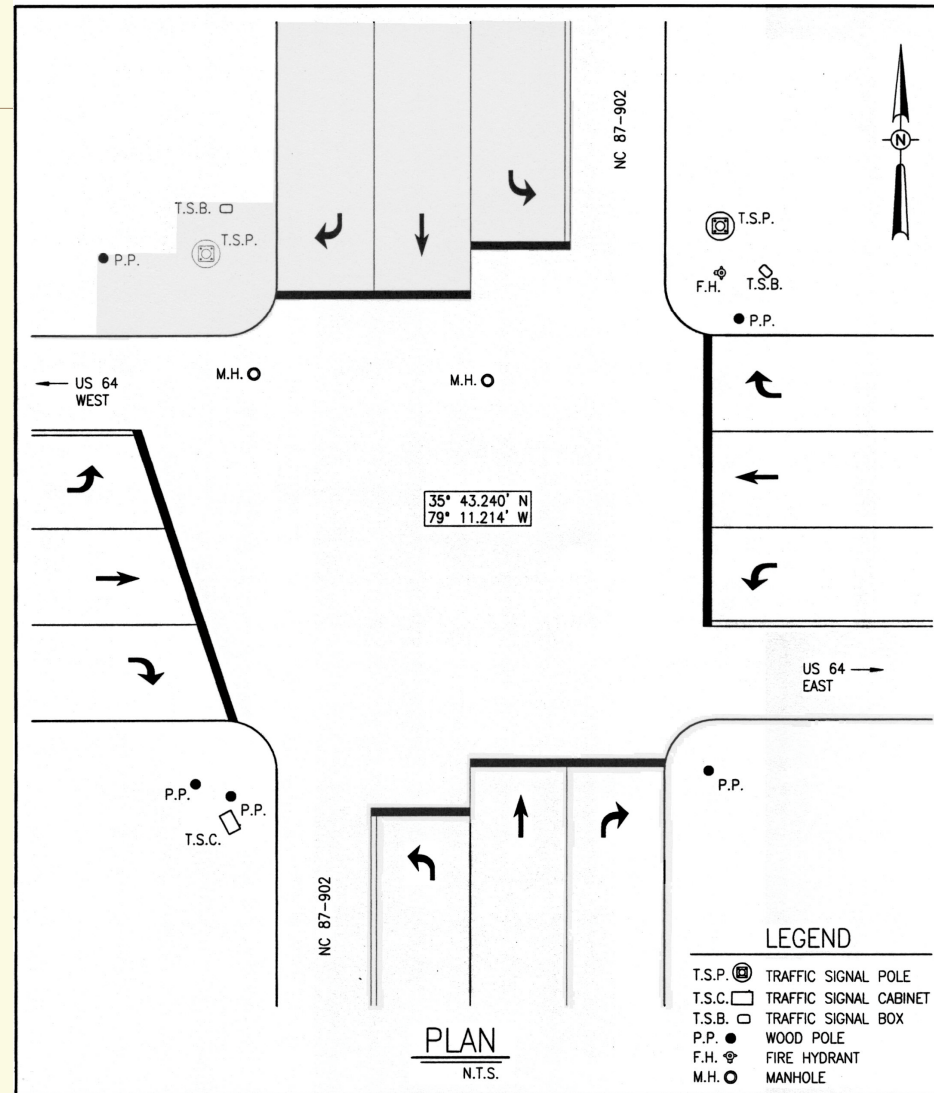
# FIELD SKETCH

ITEM	RATING	DESCRIPTION	
1a FOOTING	- NO GRADE	There is asphalt pavement around the base to bottom of base plate. There is a 1-1/2" gap at one corner of the baseplate, allowing partial inspection. Footing is not accessible.	
1b BASE PLATE OR CASTING	7 GOOD	Surface rust at anchor bolts. No grout pad and no animal screen.	
1c ANCHOR RODS	7 GOOD	Surface rust at projecting ends.	
1e ANCHOR ROD NUTS	7 GOOD	Spot surface rust on washers.	
1g VERTICAL SUPPORT BASE PLATE WELD	7 GOOD	At a few locations, galvanized coating is chipped and surface rust beginning.	
2a VERTICAL POST	7 GOOD	1 hand hole cover screw is missing. Few spots of surface rust (top 5 ft.)	
7 CONNECTION OF STRAIN WIRES TO POLE	7 GOOD	Surface rust on U-Bolt strain wire connection.	
INSPECTED BY:	WLY	REVIEWED BY:	TGZ

- 1 Provide a grout pad or animal screen to prevent access to the pole interior. Verify no interior damage from animal activity.
- 2 Replace missing hand hole cover screw.

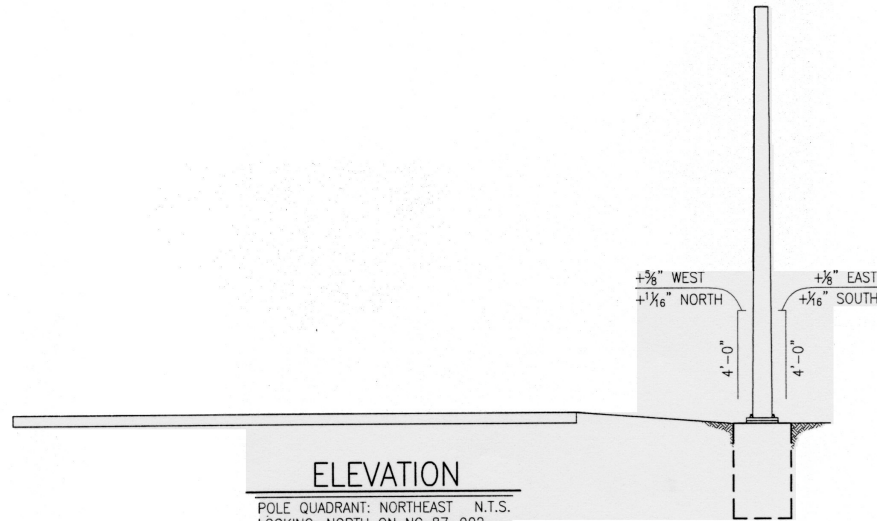
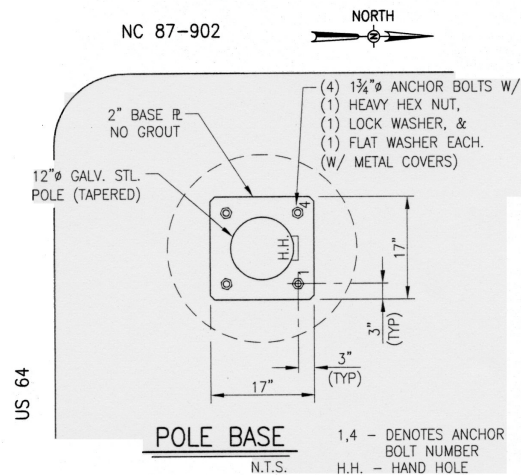
# FIELD SKETCH

NOTE: NO SCREEN (OPEN BASE)
